# Smoke and Dye Testing Summary

## High Level Sewershed

Test ID	Test Type	Date Inspected	Company / Super.	Blower MH	Ground Condition	Notification Made?	Total Length
S1028-131	Smoke	10/21/2008	ADS/TM	S13II_047MH	Dry	Yes	724.92

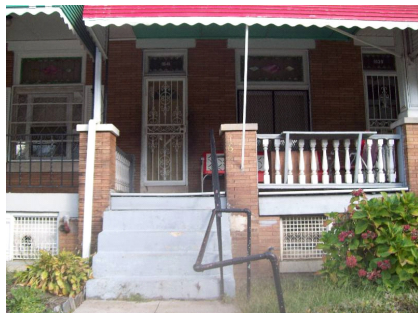
**Picture** \S1028-131-OB01-P01.jpg

**Source** Service Lateral

**Location** Paved concrete

**Comments** Smoke from service lateral underneath concrete stairs. 1641 Poplar Grove St.
